## Stone by Stone Province House Conservation Project

## Ongoing Conservation Work at Province House National Historic Site

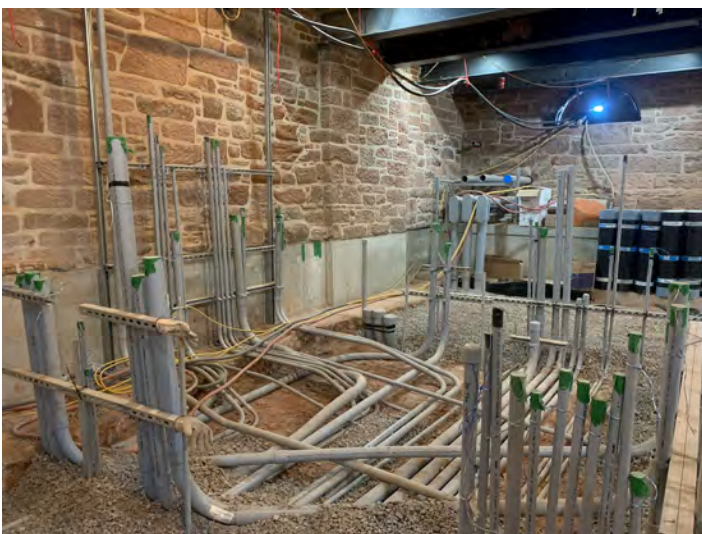
The basement floor under the slab is a maze of grey pipes for the underground services including septic, water, electrical, and communication conduits.

The concrete is being poured according to the three main heating zones. The finished concrete slab will be about 5 inches thick with about 8 inches of gravel below it.

Before this work could get underway, the underground services including septic, water, electrical, and communication conduits had to be installed. The basement floor under the slab is a maze of grey pipes (see photo below). The conduits were buried in a trench then covered with rigid insulation and waterproofing membrane. Rebar grids placed on top of the waterproofing provide structural strength for the floor slab and provide a lattice to attach heating tubes for the new hydronic heating system. “It’s very effective heat, especially for this building,” said Brian Willis, Onsite Project Manager. “It radiates heat into the concrete and stone walls and plays into the whole building.”

Once that work is complete, the plumbers, electricians and communications technicians can begin to tie their systems together through the conduits embedded below the floor.

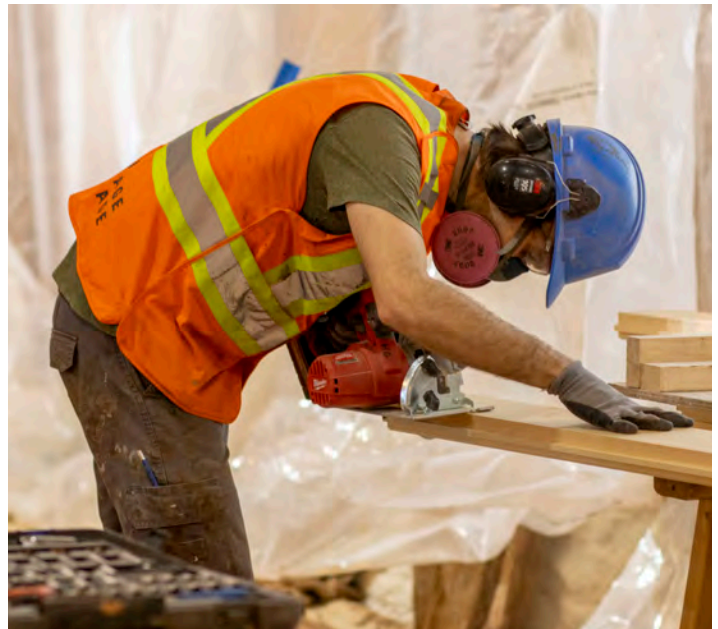
The carpentry team is replacing any worn or rotten pieces of the floors with white pine – the same material used originally.

Floor repair work is also proceeding at the site. The carpentry team is replacing any worn or rotten pieces with white pine – the same material used originally. The team did find a section of old hardwood flooring in excellent shape in the east pavilion, and they plan on refinishing that section.

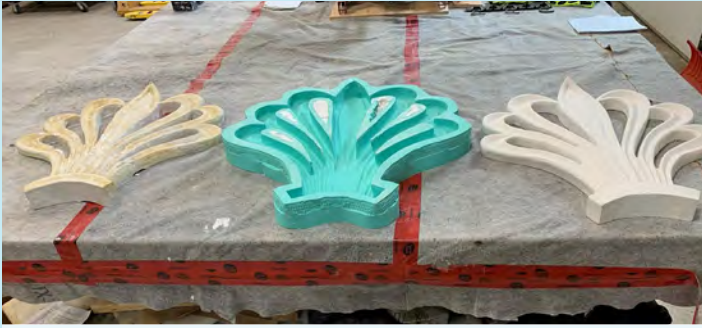
Some of the intricate decorative plaster work is created using silicon molds.

The medallions are made using silicon molds as the deep undercuts and details can’t be run on a bench. Reid said the most decorative elements are the medallions located in the Confederation Chamber and the Legislative Chamber.

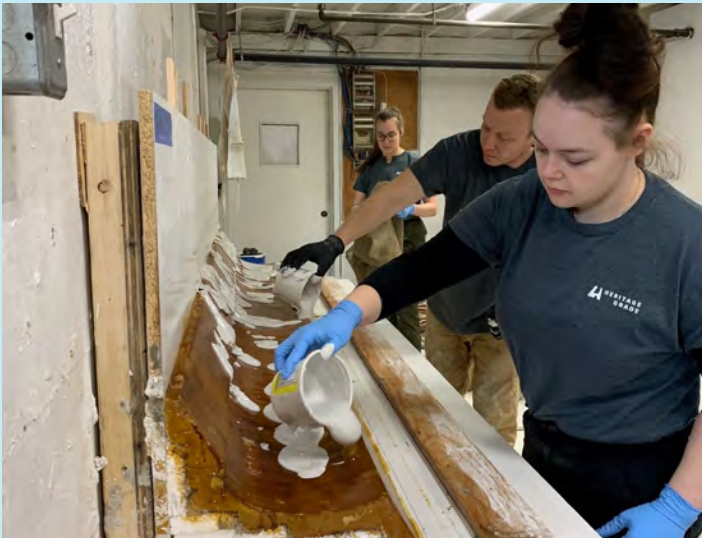
Plasterers pour gypsum plaster on the bench before running the slipper over it to create a cornice (decorative moldings along the top of the interior walls) for Province House National Historic Site.

The process of making a cornice involves creating a profile that matches the original cornice. There are approximately 10 different cornice profiles in the building. Plasterers apply gypsum plaster with trowels to a bench and then use a slipper (a cutout template made of wood and zinc that matches the profile) and run it along the bench by manually pushing it from one end to the other. This process is carried out about 40-50 times, and it becomes harder with each run. The gypsum gives off a lot of heat as it expands and dries. The slipper will jam if the plasterer is not running it fast enough along the bench.

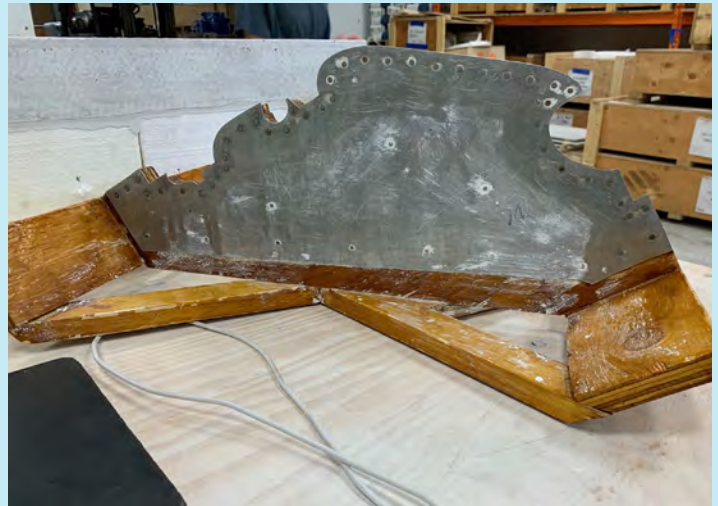
The slipper- a cutout template made of wood and zinc that is run along the bench to create a cornice.

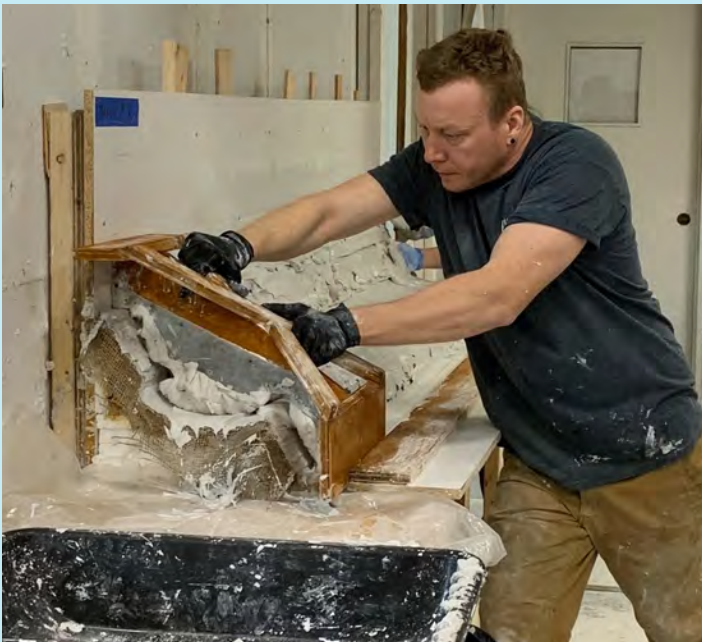
A plasterer pushing the slipper along the bench. This process is carried out about 40-50 times within a 20–25-minutes timespan.

“It sets really quick, so you have to do it in a space of 20-25 minutes,” said Reid. “It’s quite high pressure and very labour intensive.”

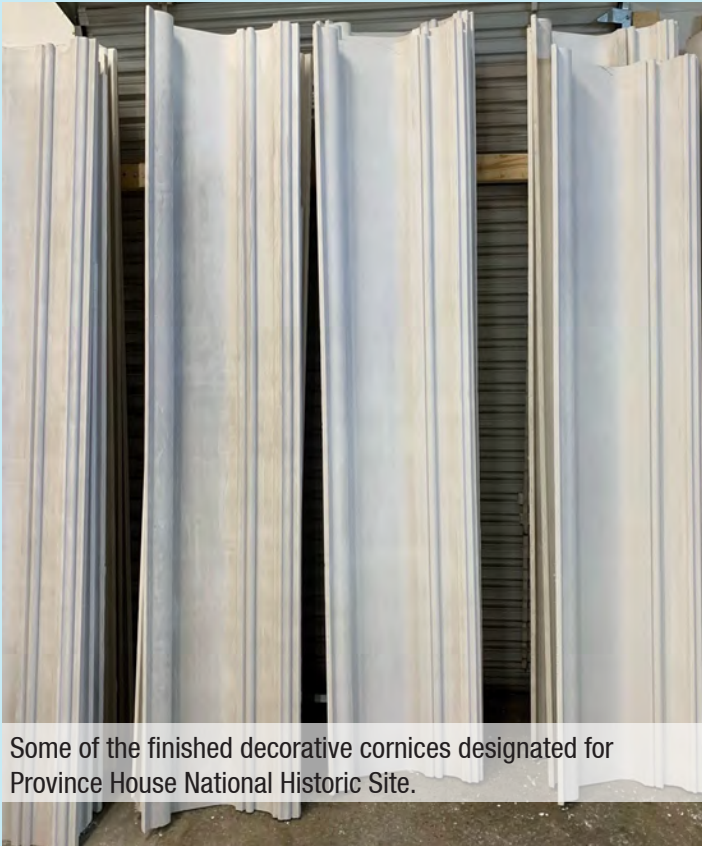
Some of the finished decorative cornices designated for Province House National Historic Site.

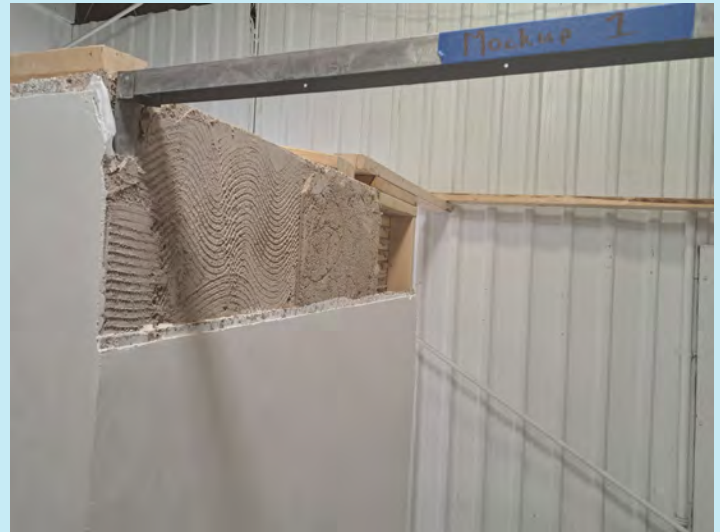
Mock-up of the lime plaster walls for Province House National Historic Site.

The team will also be on site making the walls. The walls consist of three coats; the first layer consists of lime, sand, and hair, the second layer consists of lime and sand, and the third layer consists of lime plaster. This kind of wall is durable and fire resistant and allows the walls to breathe and prevents moisture buildup from the exterior stone walls.

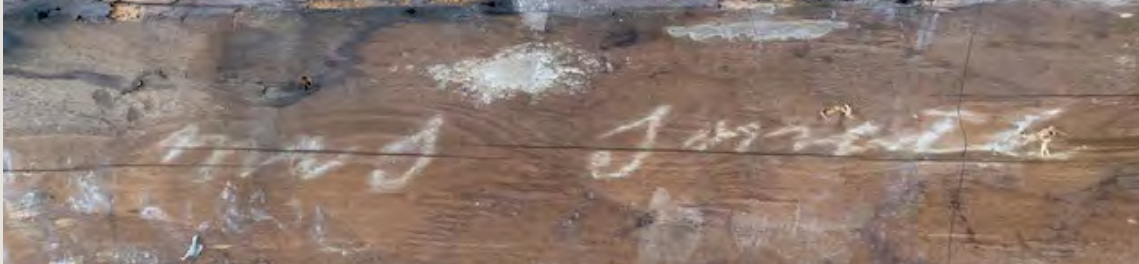
Isaac Smith's signature, the architect who designed Province House in Charlottetown and supervised the construction of the building between 1843-1847, was found along the underside of the southwest balcony in the Confederation Chamber in spring 2023.

The signature on the underside of the southwest balcony was quickly pointed out to Large and Scott. The excitement in the room was palpable. “Once we saw the signature in the bible, we knew it was Isaac Smith’s signature on a rough piece of wood instead of a smooth piece of paper,” said Willis. “I think he signed it upside down because the gap between Mr. I and Smith is so wide.”

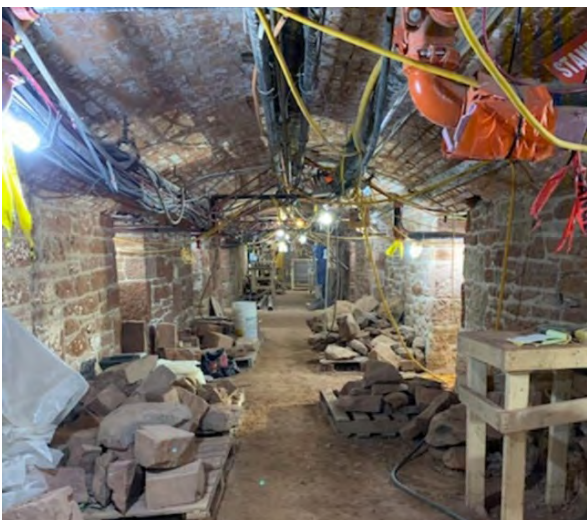
Before the basement consolidation work. Electrical wires used to hang down from the low ceiling.

The contractor, Amcon Limited, installed concrete underpinning and lowered the cellar floor by one meter to create enough headroom so the basement could accommodate accessible and inclusive washroom facilities, a lunchroom, storage facility and a mechanical and electrical service room.

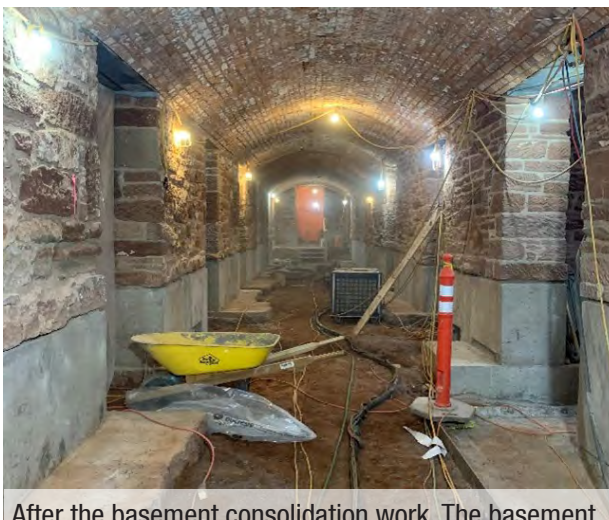
After the basement consolidation work. The basement floor was lowered by one meter so that it can be a useable and accessible space.

The process involved digging a hole about a meter long and a meter deep under the interior foundation walls. Thankfully, modern-day technology made this process slightly easier with the use of pneumatic shovels to loosen up the soil and a giant vacuum was used to remove the debris. A total of 90 tandem loads of soil and rock were removed from the basement during the process.

After a hole was dug, a footing with reinforcing steel was poured, followed by vertical formwork to the underside of the existing masonry wall.

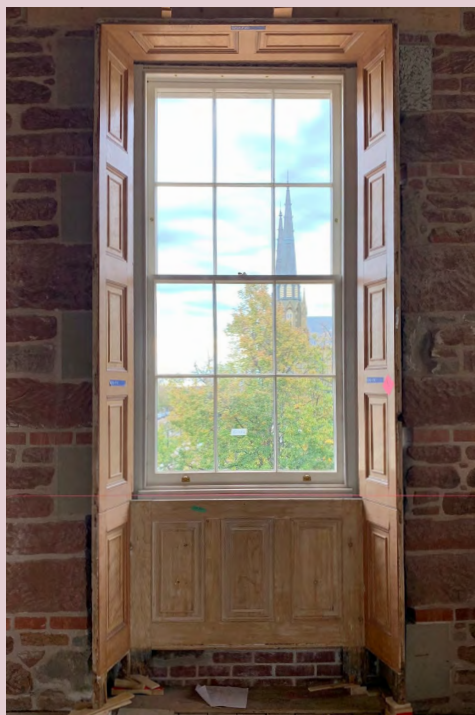
One of the conserved windows at Province House National Historic Site.

The windows in the building vary in size: 47" wide and 22" high in the basement; 53" wide and 85" high on the first floor; 57" wide and 97" high on the second floor; and 53" wide; and 48" high on the third floor. The windows with the bow top on the first floor were the largest measuring 53" wide and 207" high and were tricky to repair because of the curvature in the wood.

The windows where the walls had been repaired in situ, meaning restored in place, also proved challenging. Modern day standards require airspace between the stones and the wood to prevent rot. Weather stripping was also added to improve the energy efficiency. This meant there were a lot of alterations done onsite.

of measuring and making adjustments, as necessary." Straight grain Douglas fir was used to replace rotten sections of a frame. This type of wood was chosen because it worked well with the old growth pine of the original windows.

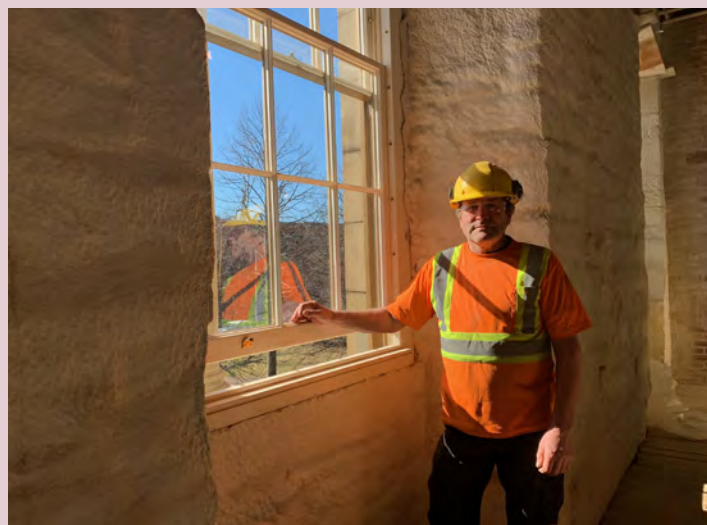
Gary Loo, of Wheatley River, PEI, has been involved with the Province House conservation project since 2021 and assisting with the assembly process, onsite restoration work, and installation. The windows in the library (pictured) were some of the more challenging windows to install due to the natural bow in the wall.

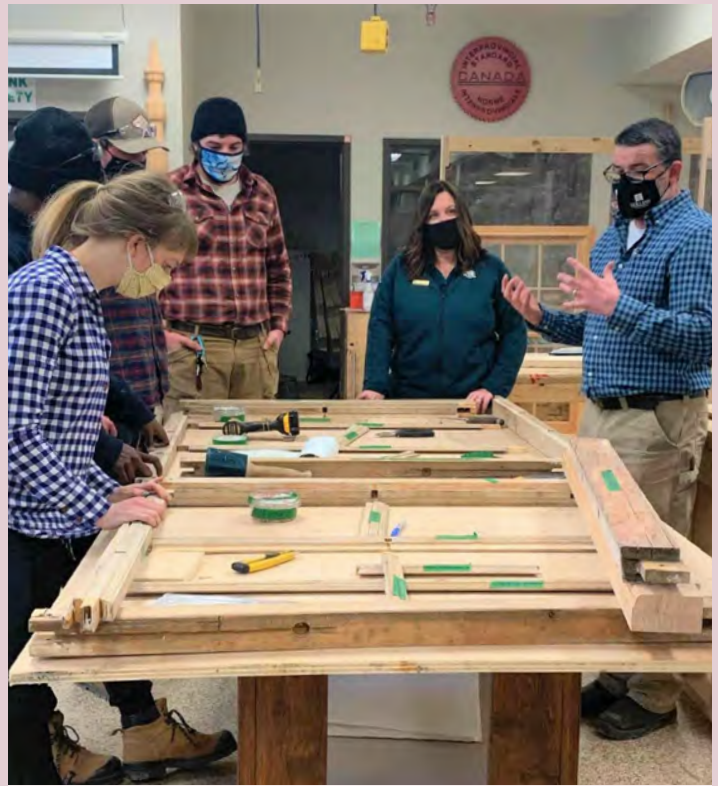
Two of the original windows were conserved by students from Holland College’s Heritage Retrofit Carpentry program. Students began this process in 2019, under the guidance of Josh Silver, Learning Manager for the Heritage Retrofit Carpentry program. An expert conservator also worked with students in this exceptional training experience. The students reinstalled the windows at the site in May 2022.

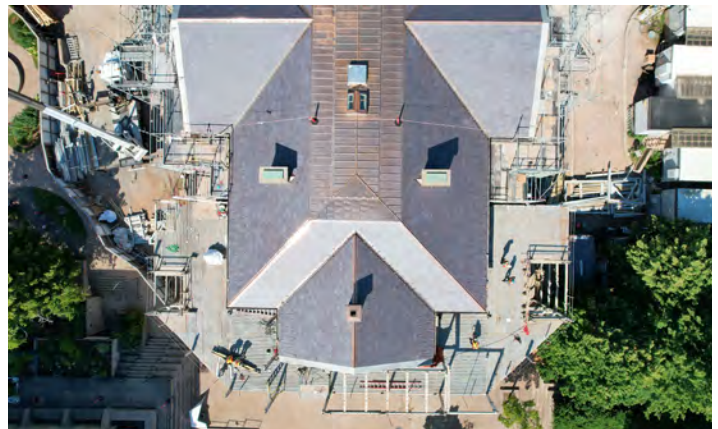
A drone image of the completed roof work.

back to the rafters. They proceeded to replace the rotten rafters and brought the roofline to the edge of the stonework. The new design involves using copper cladding around the gutters and flashings to help create a seal. Under the slate, there are two layers of plywood with two-inch thick thermal insulation, vapour barriers and a waterproofing membrane.

The new design and modern elements ensures water infiltration won’t be an issue moving forward. The roof work was completed in August 2022.

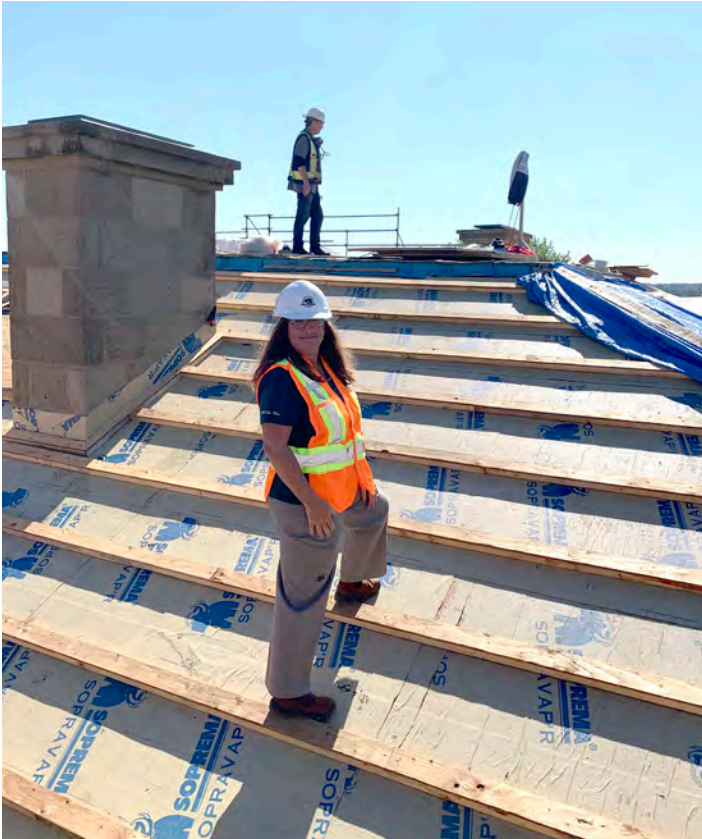
Nicolle Gallant, Project Manager for the Province House conservation project, on site when the roof work was underway. The new roof combines traditional materials with modern day elements ensuring water infiltration won’t be an issue moving forward.

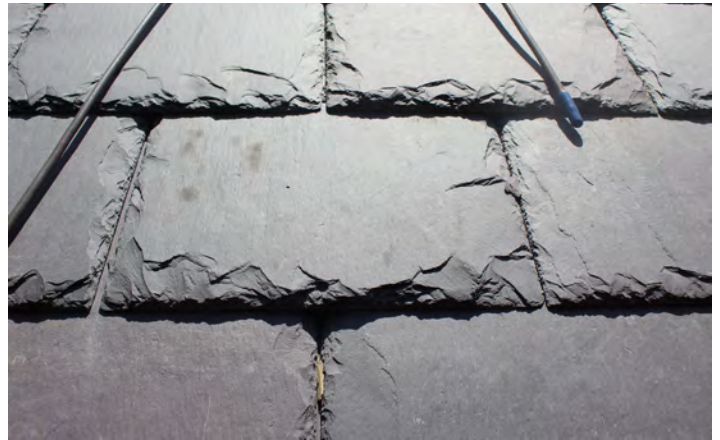
A close-up image of the new slate shingles at Province House National Historic Site. The new slate is sourced from the same location when Province House was constructed between 1843-1847.

The last time the roof was replaced was in the 1980s and the slate material came from a quarry in Vermont. Since the quarry was unable to supply replacement materials, the Province House conservation project team had to search for similar slate material elsewhere. After a fair bit of research, the team was able to source slate material from North Wales that is original to when it was first constructed between 1843-1847.
